T-55 Engine Compressor Stator Vane Investigation

ARL-TR-2123

November 1999

Weapons and Materials Research Directorate, ARL

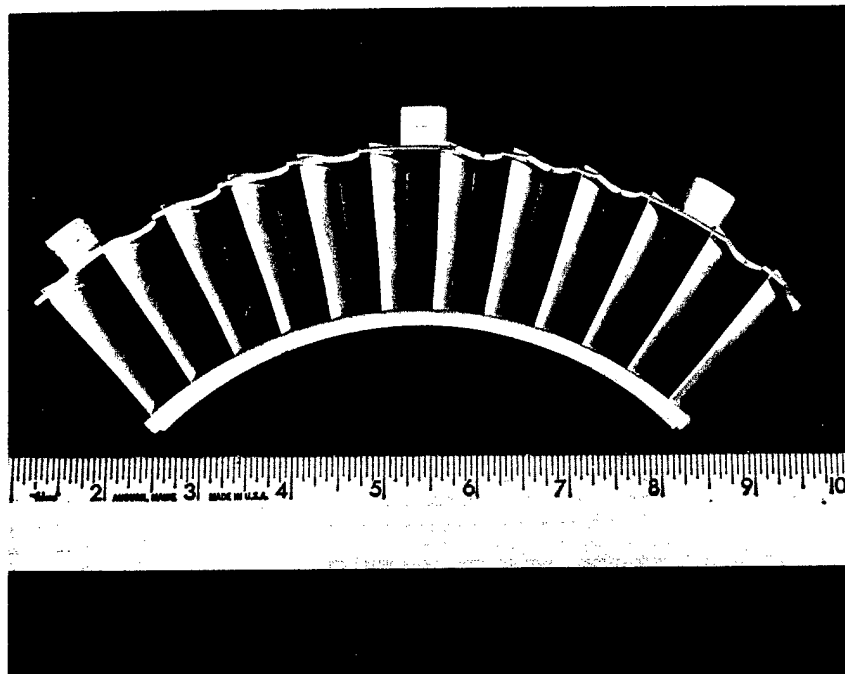
3.1 Sectioning. The sixth stage engine compressor stator vane assembly is governed by Avco Corporation's Drawing Package 2-100-060-26 [1]. Figures 1 and 2 depict the stator vane assembly initially sectioned in half. Figure 2 shows the additional dissection of the component for examination and testing. Portions of the individual vanes were needed for bend and

Figure 1. Sectioned Half of the Stator Vane Assembly (Reduced Approximately 0.75×).

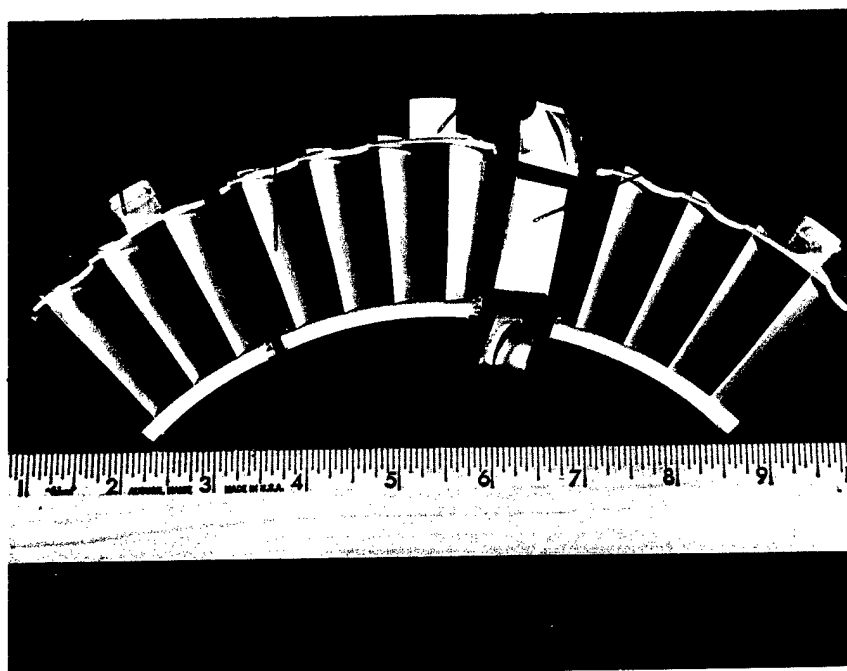
Figure 2. Additional Dissection of the Stator Vane (Reduced Approximately 0.75×).

corrosion testing as well as for the coating thickness measurements. Two three-vane segments of the component were also sectioned, one of which was sent to Electro-Methods Inc. and one subjected to corrosion testing at ARL-WMRD.

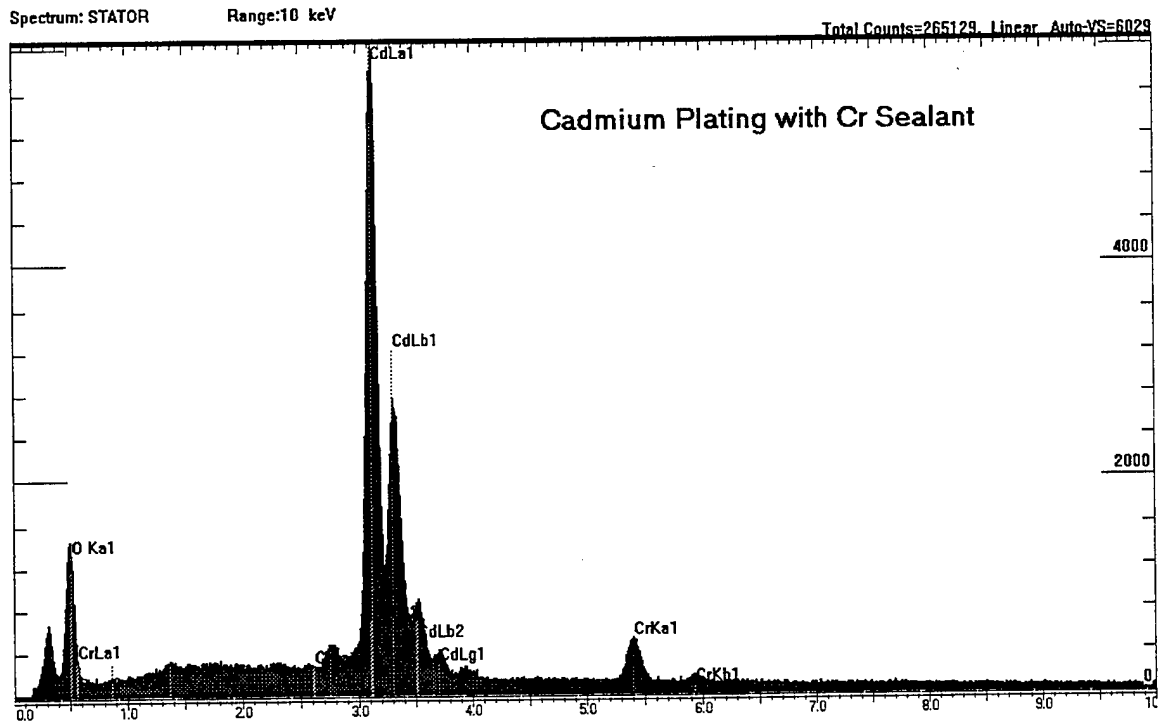
Specification AMS 2400 Rev. S stipulates that the cadmium must be sealed with a chromic acid sealant or with a chromate or phosphate treatment when specifically approved [2]. An attempt was made to verify the existence of a chromium or phosphorus sealer over the cadmium coating. These sealers would be evidenced by the presence of the elements Cr or P, respectively, within the EDS spectrum. Neither element was observed above the scatter within the EDS spectrum. Figure 18 presents the EDS spectrum from a representative stator vane. The only elements observable in Figure 18 are oxygen (O) and cadmium (Cd). To further investigate, a cadmium-plated nut known to have a chromate sealer was analyzed and indeed was found to contain a significant amount of the element Cr within, or on top of, the cadmium coating. Figure 19 presents the EDS spectrum showing the Cr peak. These findings suggest that either the sealer was absent or below detectable limits. In either case, the corrosion protection afforded would be minimized.

Figure 19. EDS Spectrum Showing a Detectable Cr Sealant on a Cadmium Nut.

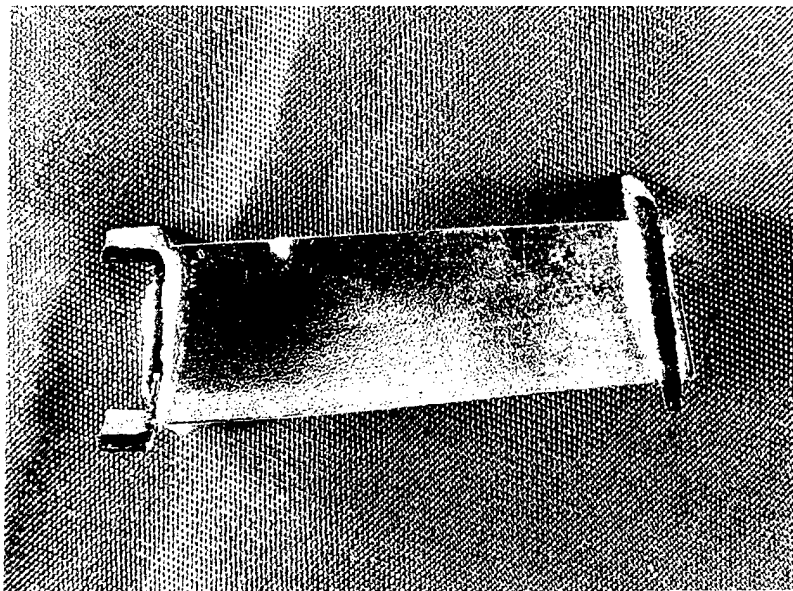
4.1 Corrosion Testing. The most recently received assembly was tested side by side against sections from the old component that had been chromic acid dipped (0.42% chromic acid, the minimum recommended by the manufacturer, and 2.33% chromic acid) according to the suggestions of MacDermid. Figures 20 and 21 depict a section of the new stator before salt fog testing. Figures 22 and 23 show the old component that had been dipped in 0.42% chromic acid for comparison. The extremely bright shiny cadmium coating on the new stator can be directly

Figure 20. New Section of the Stator Vane, Concave Side (Magnified 1.5×).

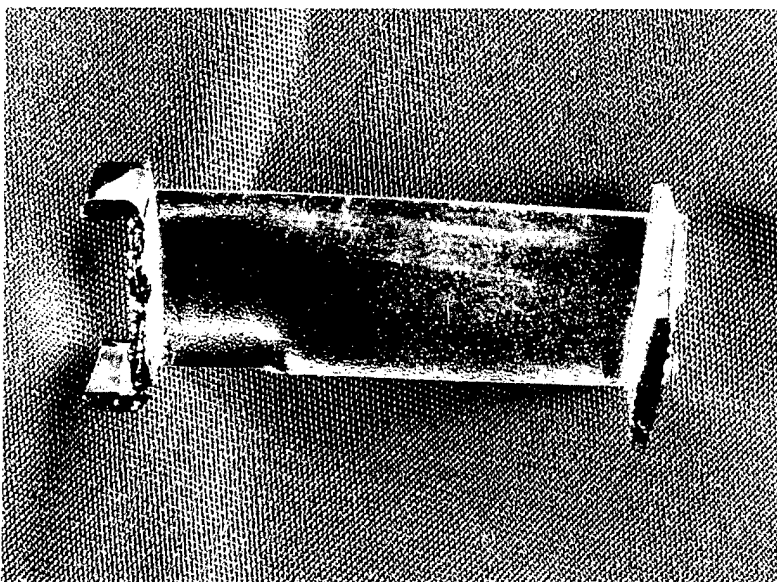
Figure 21. New Section of the Stator Vane, Convex Side (Magnified 1.5×).

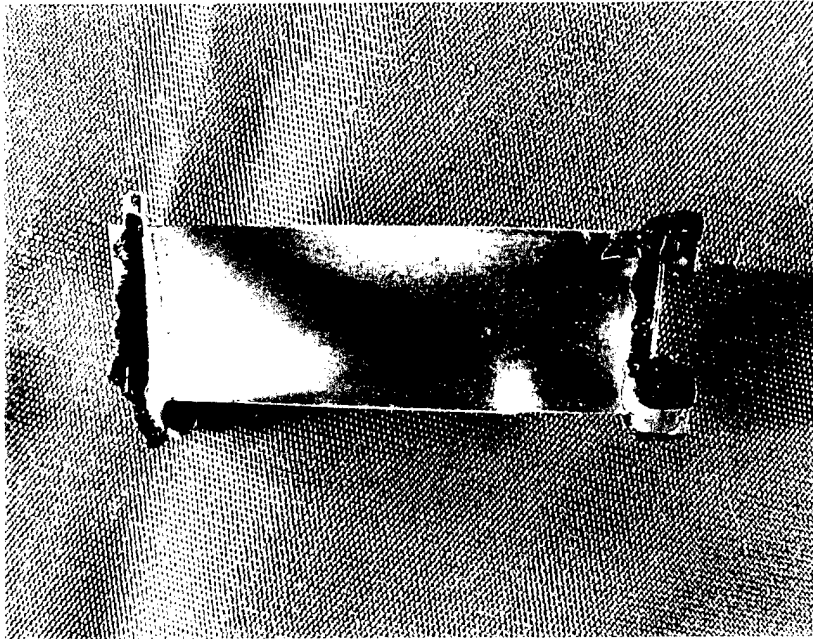
Figure 22. Previous 0.42% Dipped Stator, Concave Side (Magnified 1.5×).

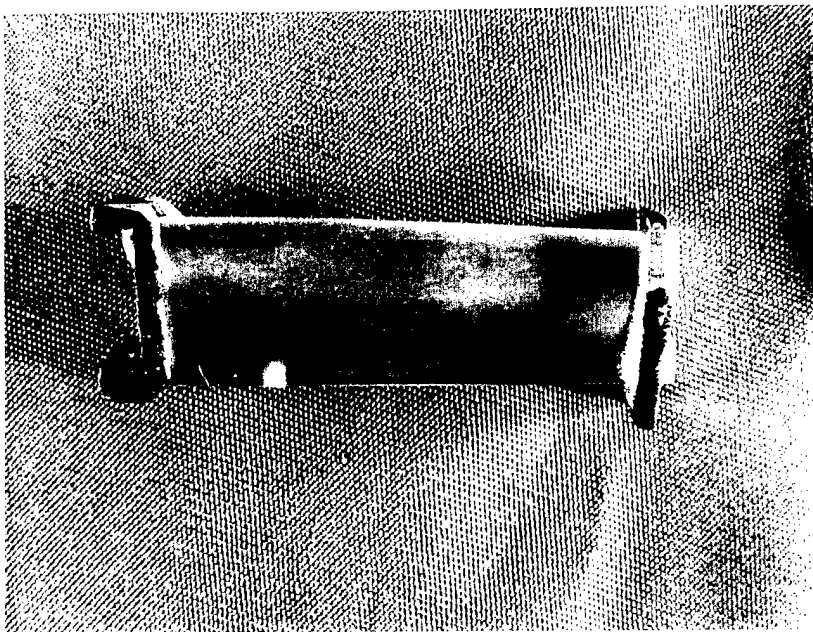
Figure 23. Previous 0.42% Dipped Stator, Convex Side (Magnified 1.5×).

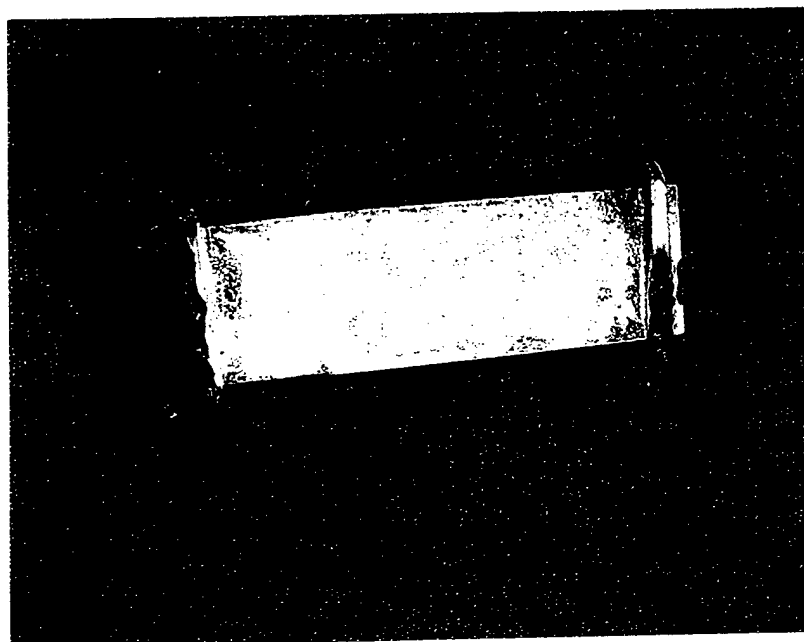
Figures 28–31 show the new and old (0.42% dipped) stator section after 24 hr of salt fog exposure per ASTM-B-117, respectively (compare with Figures 20–23). Even with the new cadmium coating, the performance of the 0.42% chromic acid dipped stator is superior after 24 hr exposure.

Figure 28. New Stator Section After 24 hr Salt Fog Exposure, Concave Side (Magnified 1.5 \times).

Figure 29. New Stator Section After 24 hr Salt Fog Exposure, Convex Side (Magnified 1.5 \times).

Figure 30. 0.42% Dipped Stator After 24 hr Salt Fog Exposure, Concave Side (Magnified 1.5×).

Figure 31. 0.42% Dipped Stator After 24 hr Salt Fog Exposure, Convex Side (Magnified 1.5×).

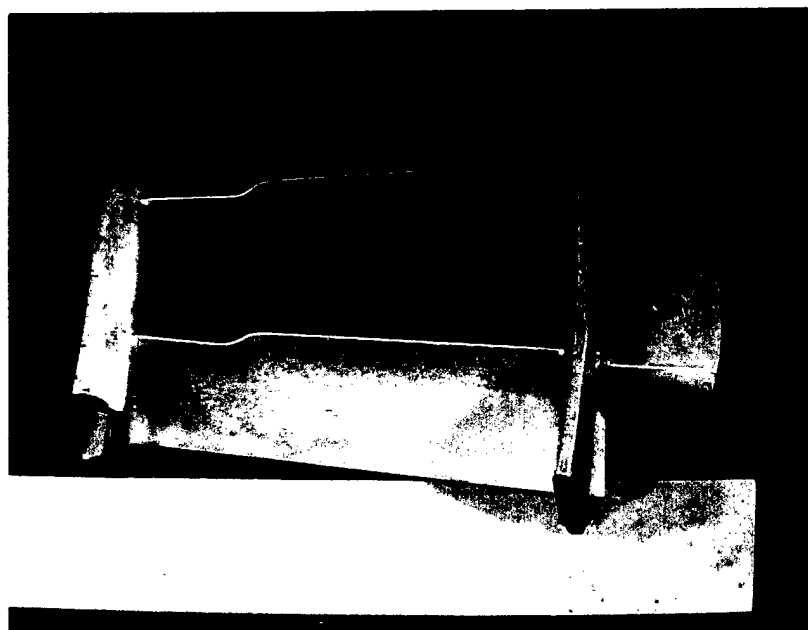
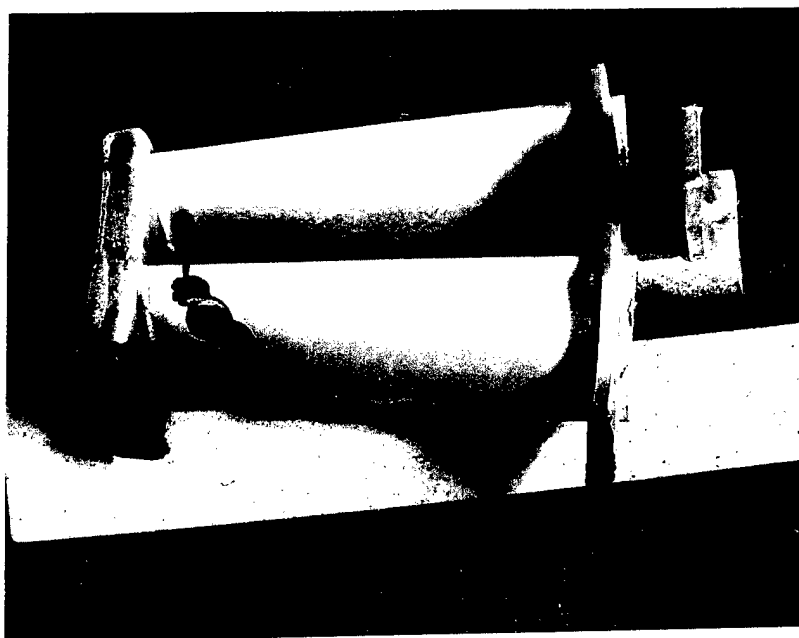
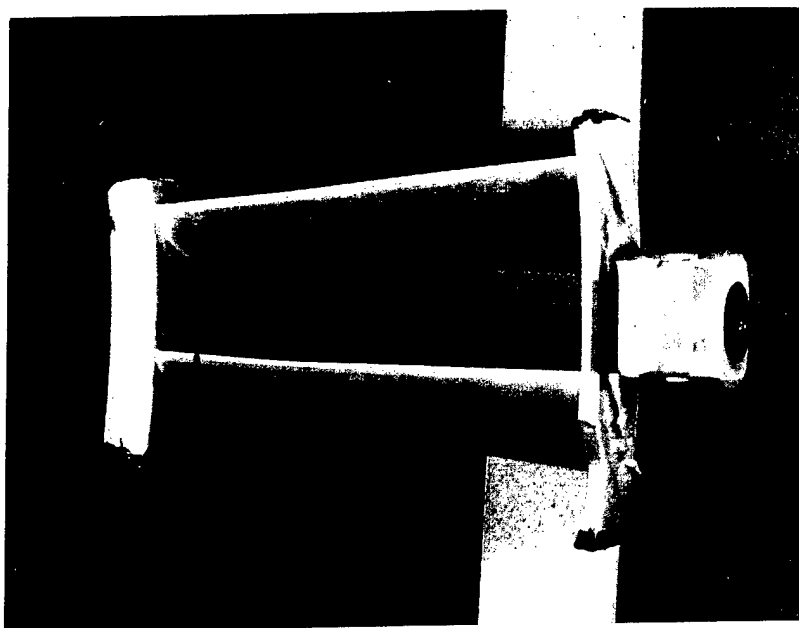
Figure 32 compares the new and old (0.42% dipped) stator sections showing the inner shroud braze area. Both stator sections show only some white cadmium oxide product. No reddish-orange corrosion of the steel is present. Figures 33–35 show that the old (2.33% dipped) stator shows no significant corrosion at all, after 24 hr salt fog exposure.

Figure 33. 2.33% Dipped Stator After 24 hr Salt Fog Exposure, Concave Side (Magnified 1.5 \times).

Figure 34. 2.33% Dipped Stator After 24 hr Salt Fog Exposure, Convex Side (Magnified 1.5x).

Figure 35. 2.33% Dipped Stator After 24 hr Salt Fog Exposure, Braze Area (Magnified 1.5x).

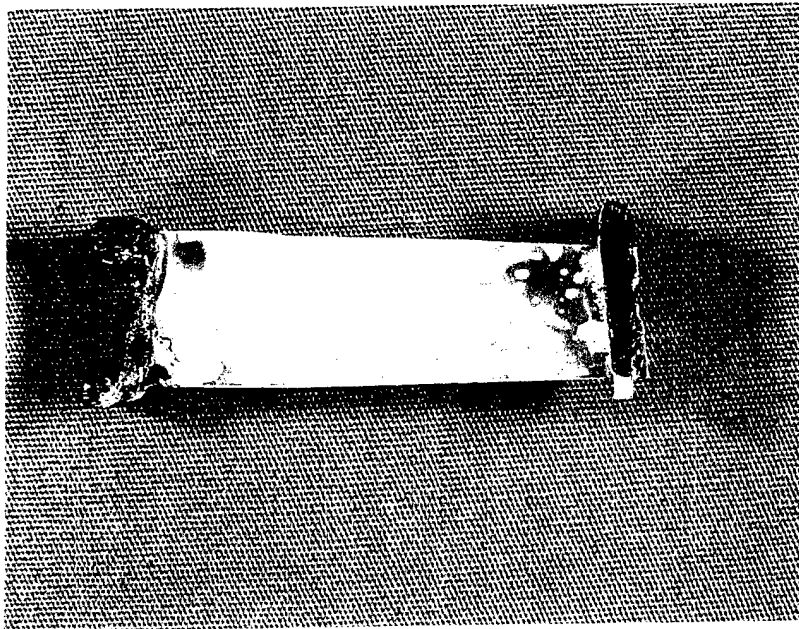
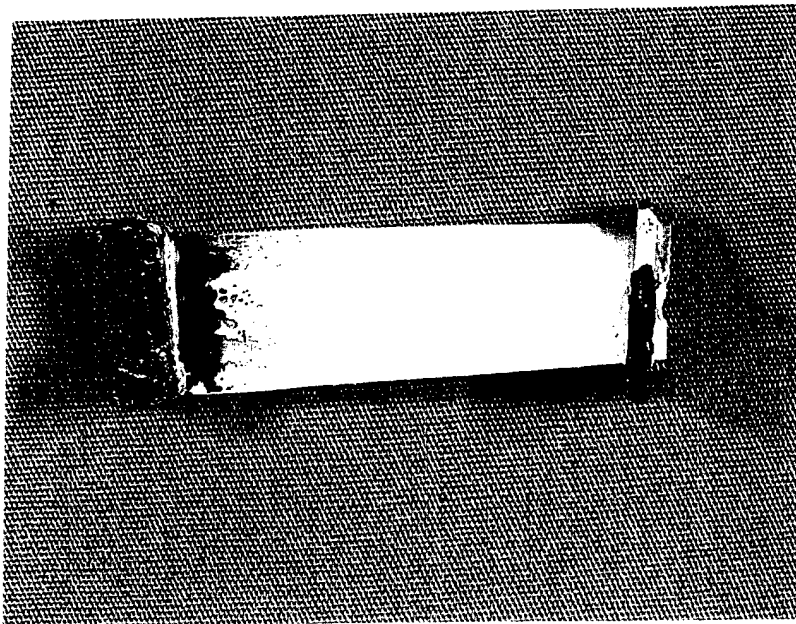
After 200 hr exposure per ASTM-B-117, the new stator exhibited significant white product along the vane and severe pitting within the braze area, as shown in Figures 36 and 37. Figures 38 and 39 depict the corrosive action on the 0.42% dipped old stator and general corrosion can be observed. This general corrosion was more representative of the previous results obtained. However, the area of corrosion seemed to be limited to the inner shroud braze area. Comparative macrographs of the new stator vs. the old 0.42% dipped stator are shown in Figures 40 and 41. After 200 hr of exposure, general corrosion of the 0.42% dipped stator was observable near the inner shroud brazed area and pitting was observable on the new corrosion system stator. It could not be determined which corrosion-resistant coating performed better. Neither would pass the corrosion requirements established in AMS 2400 Rev. S [2].

Figure 38. 0.42% Dipped Stator After 200 hr Salt Fog Exposure, Concave Side (Magnified 1.5×).

Figure 39. 0.42% Dipped Stator After 200 hr Salt Fog Exposure, Convex Side (Magnified 1.5×).

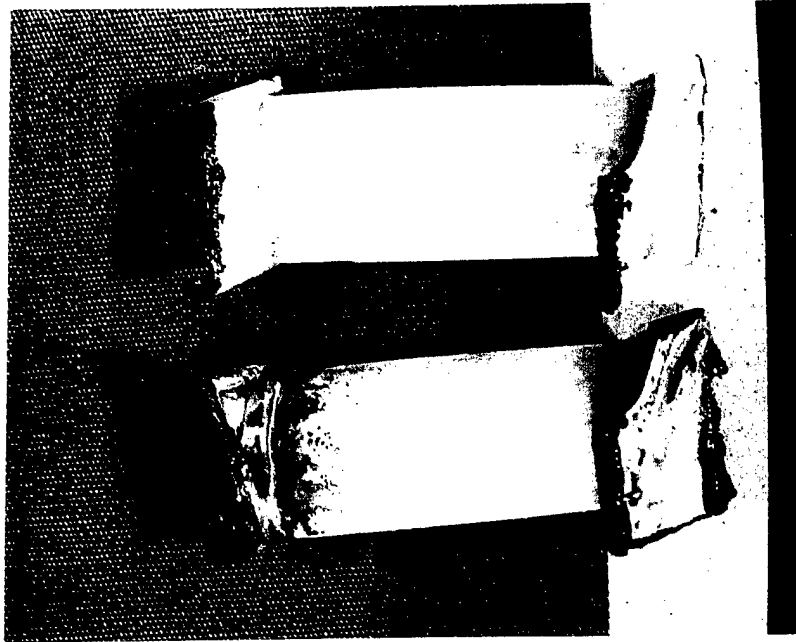
Figure 40. 0.42% Dipped and New Stator Sections After 200 hr Salt Fog Exposure, Convex Side, Braze Area (Magnified 1.5 \times).

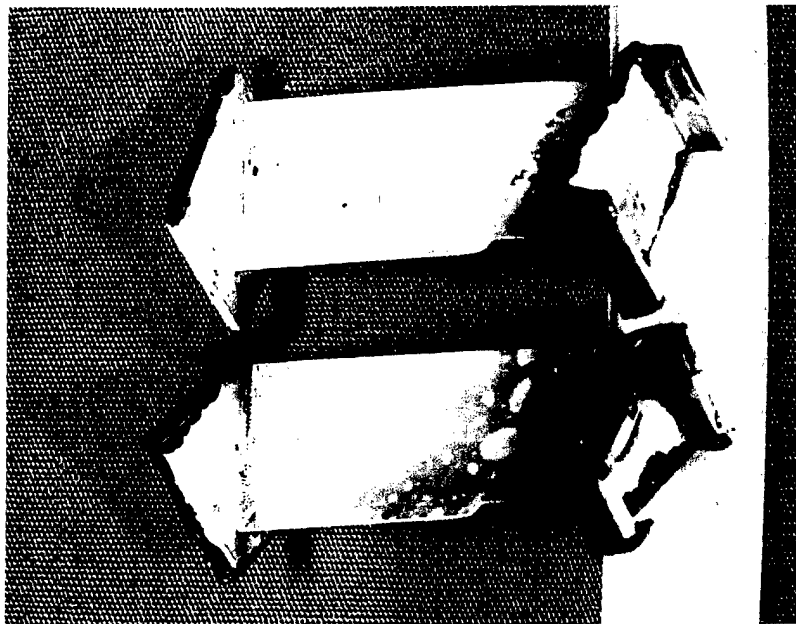
Figure 41. 0.42% Dipped and New Stator Sections After 200 hr Salt Fog Exposure, Concave Side, Braze Area (Magnified 1.5 \times).

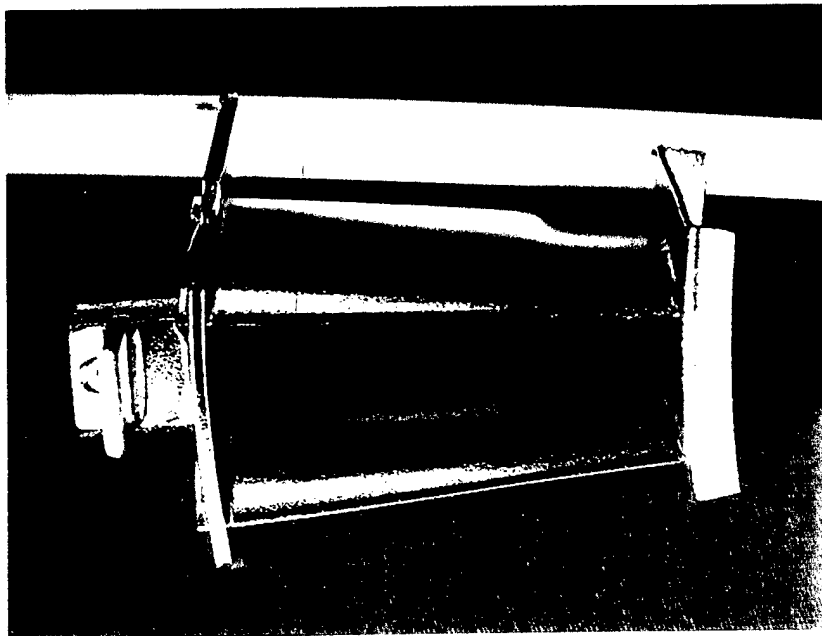
5.2 Corrosion Testing. The most recently received stator section was salt fog tested in accordance with ASTM-B-117. Figures 50 and 51 depict the concave and convex sides of the section before salt fog testing, respectively. Figures 52 and 53 show the inner shroud vane braze area with more clarity, also prior to salt fog exposure. The yellow iridescent hue of a chromium sealer is clearly evident.

Figure 50. Replated Section of the Stator Vane, Concave Side (Magnified 1.5×).

Figure 51. Replated Section of the Stator Vane, Convex Side (Magnified 1.5×).

Figure 52. Replated Stator Section, Braze Area, Concave Side (Magnified 1.5×).

Figure 53. Replated Stator Section, Braze Area, Convex Side (Magnified 1.5×).

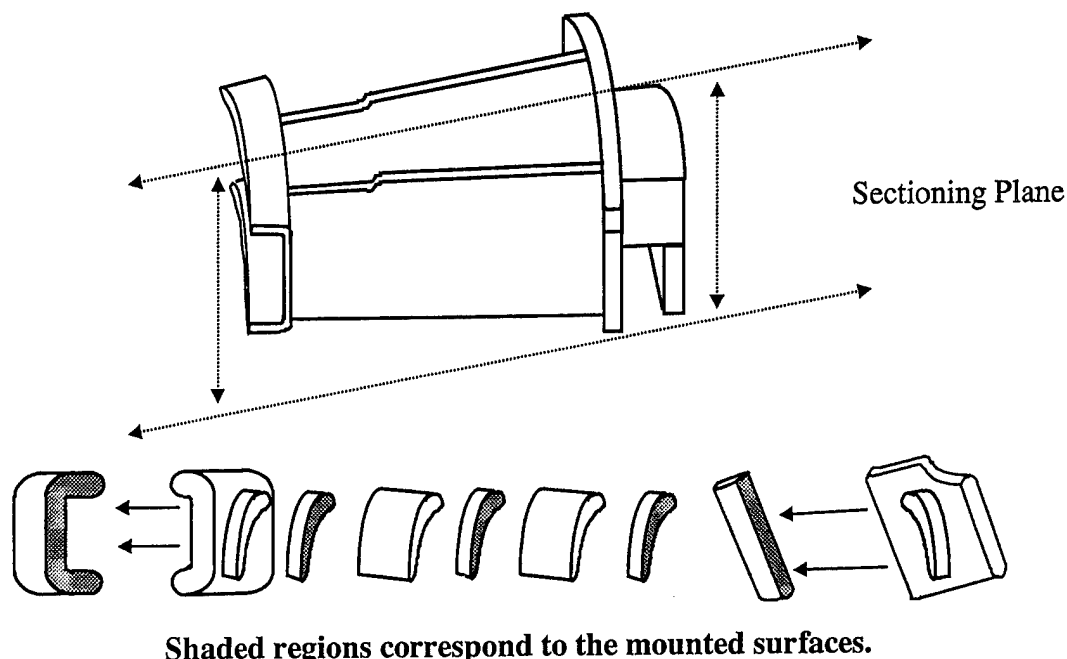
Figure 63. Diagram of Sectional Stator Vane.

5.3 Sectioning. The stator vane was sectioned after corrosion salt fog experiments to create several cross sections for cadmium coating thickness measurements. A sectioning diagram (Figure 63) is provided as follows:

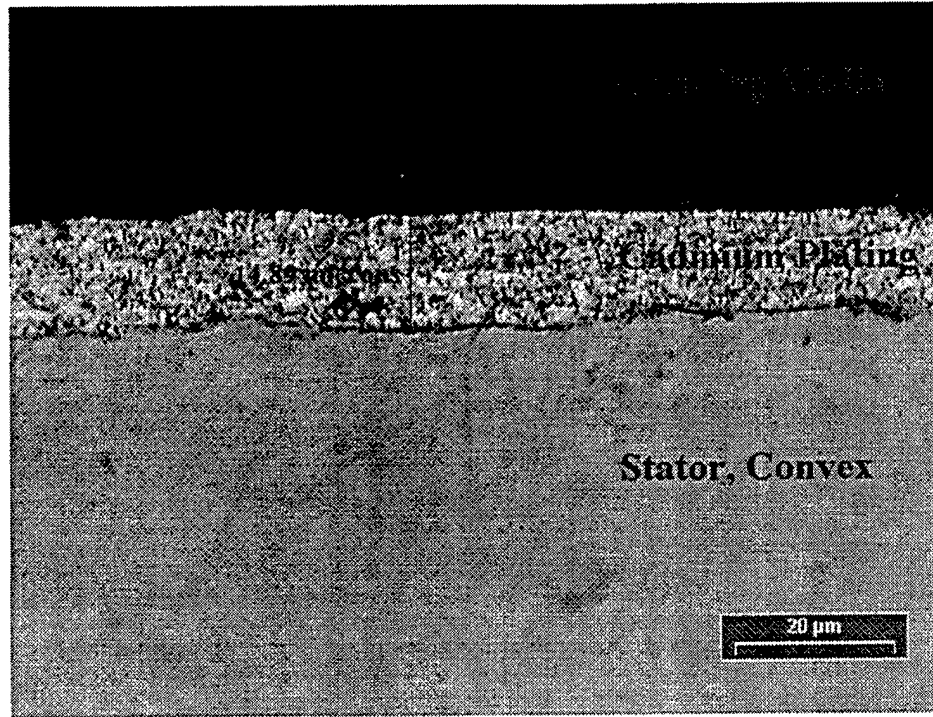
5.4 Coating Thickness. Cross sections of several vanes were prepared metallographically and examined per ASTM-B-487. Figure 64 shows a representative area along the convex side of a vane near the middle where the cadmium plating was approximately 0.00054 in thick. In contrast, Figure 65 is indicative of the cadmium plating observed on much of the concave side of a vane near the middle where the thickness was approximately 0.00043 in.

Figure 64. Cadmium Thickness, Middle of Vane, Convex Side.

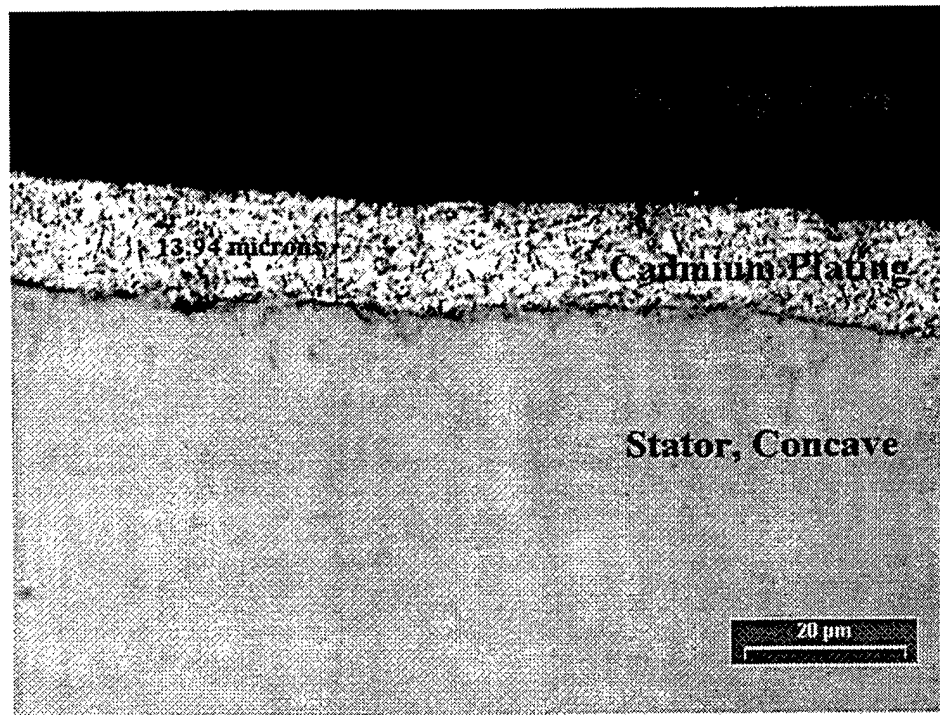
Figure 65. Cadmium Thickness, Middle of Vane, Concave Side.

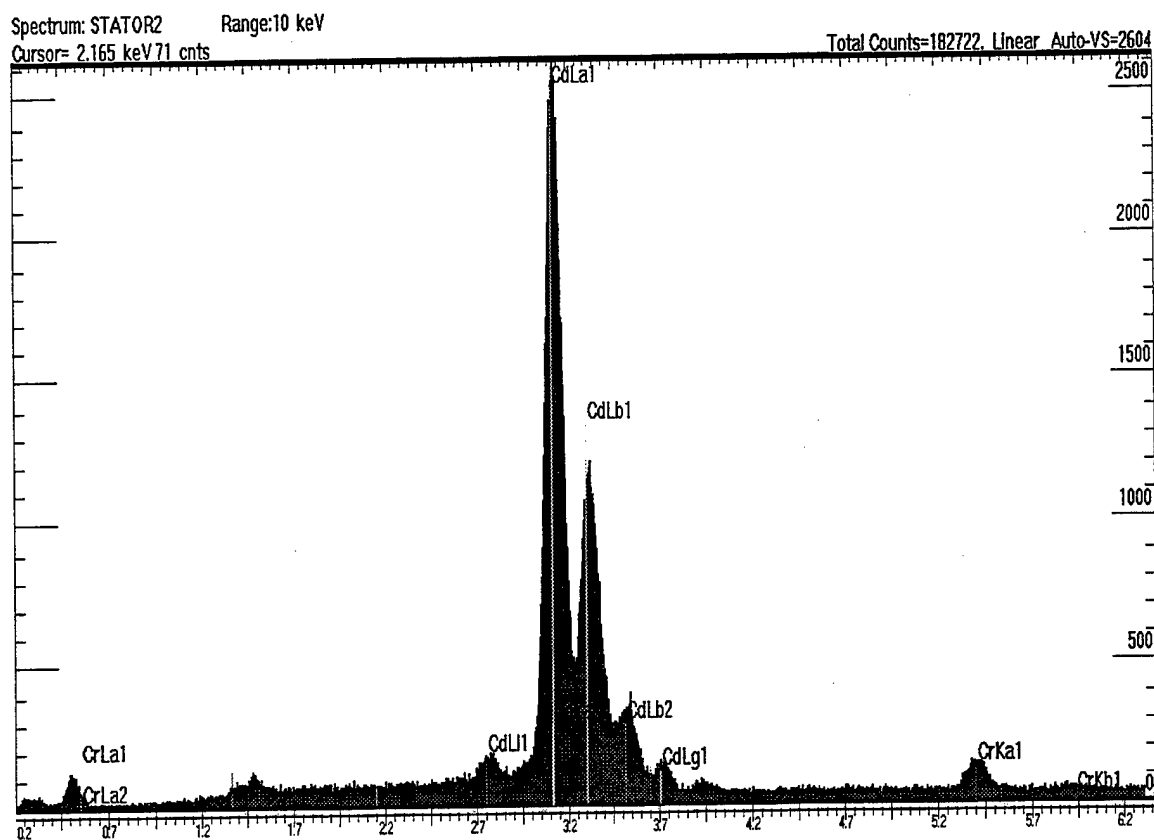
5.5 SEM/EDS Examination. Portions of the sectioned components were examined by SEM. A cadmium plating was detectable on all surfaces. Verification of the existence of a chromate or chromic acid sealer over the cadmium coating was performed with the EDS system. This was evidenced by the presence of the element chromium (Cr) within the EDS spectrum. Figure 66 depicts the EDS spectrum from the new stator vane section.

Figure 66. EDS Spectrum Indicating the Presence of Chromium.
